Description : Sample Name Stainless Steel PCH 8 Series
Model Name PCH-8215
Date of Received Jan. 25, 2021
Date of Testing Jan. 26, 2021

Conclusion	Test Information	Q'ty	Test Result	Page
	Degrees of protection provided by enclosures: IPX7	1	PASS	3
	High-Pressure/Steam Jet Cleaning Test: IPX9K	1	PASS	4

1. Degrees of protection provided by enclosures : IPX7

2. High-Pressure/Steam Jet Cleaning Test : IPX9K

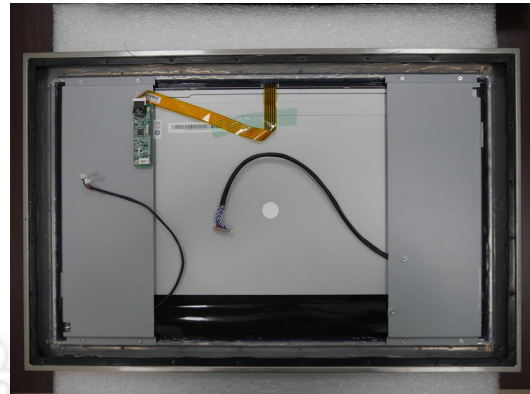
1-4 IPX7 After Test -2

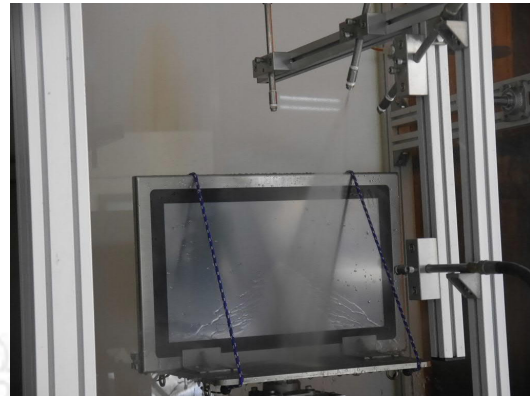
2-4 IPX9K Testing 60°

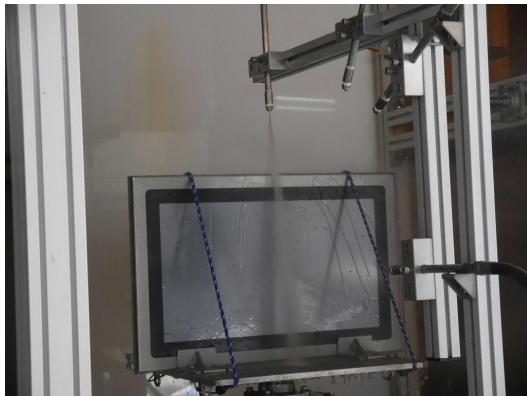
2-5 IPX9K Testing 90°

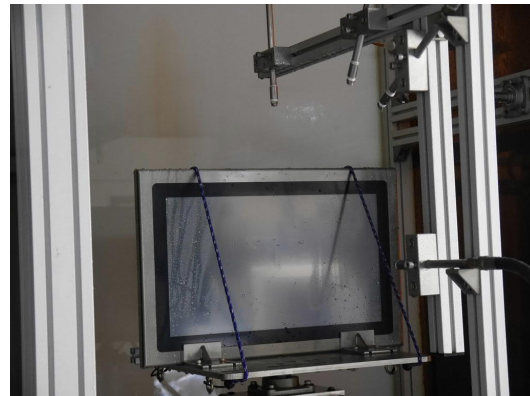
2-6 IPX9K After Test - 1

- There is no trace of water inside.
